# Manhole Inspection Summary

Manhole # S43AA\_009MH

Insp Date: **6/24/08 8:53 AM**

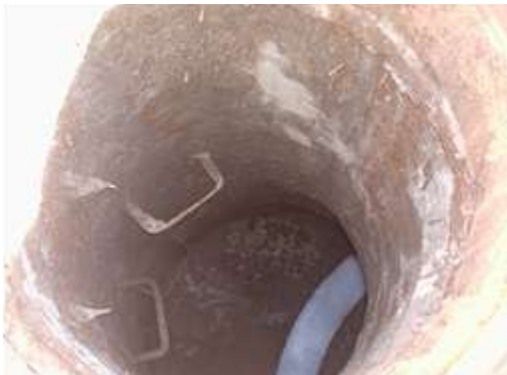
Defect 1

**Steps** Count: **5** Missing: **1** ☒ **Corroded**

Missing Steps

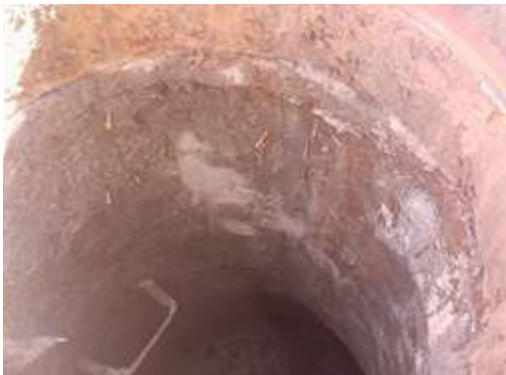
Defect 2

Infiltration: ☐ None ☒ **Joint** ☐ Cracks ☐ Mortar ☐ Roots ☐ Wall

Infiltration: ☐ None ☐ Joint ☐ Cracks ☐ Mortar ☐ Roots ☒ **Wall**

Infiltration

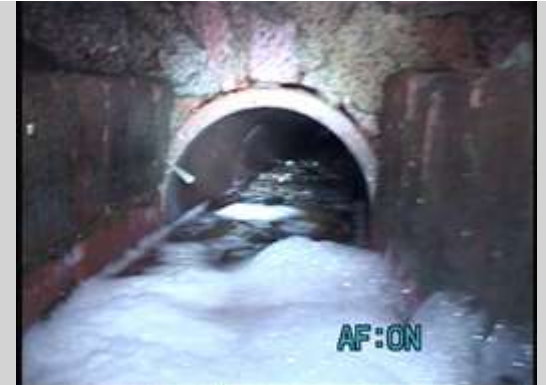
12 O'Clock Outflow

8 in. Circular Gravity Sewer  
Pipe Out @ 12 O'Clock

Pipe Height: **8.4** (in.) Rod and Bar (Angled)  
Pipe Material: **Clay** ☐ Pipe Lined  
Invert Depth: **9.65** (ft.) Flow Characteristics: **Fast**  
Deposits: ☒ None ☐ Mud ☐ Sludge ☐ Debris ☐ Grease  
Silt Depth: (in.) Deposits Extent:  
Infiltration: **None** Pipe Seal Cond: **Sound**

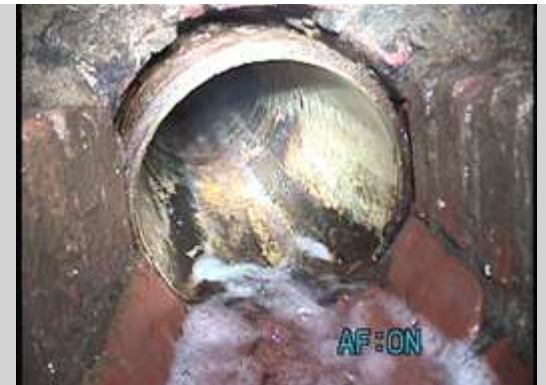
5 O'Clock Inflow

8 in. Circular Gravity Sewer  
Pipe In @ 5 O'Clock

Pipe Height: **8.4** (in.) Rod and Bar (Angled)  
Pipe Material: **Clay** ☐ Pipe Lined  
Invert Depth: **9.50** (ft.) Flow Characteristics: **Fast**  
Deposits: ☒ None ☐ Mud ☐ Sludge ☐ Debris ☐ Grease  
Silt Depth: (in.) Deposits Extent:  
Infiltration: **None** Pipe Seal Cond: **Sound**
